Evaluating the Seismic Resilience of Newly Constructed Concrete Building in Zinda Jan District After the Devastating October 2023 Earthquake in Herat, Afghanistan

Arif Alkozay¹, Rahimullah Stankzai², Amanollah Faqiri³
Herat University Afganistan

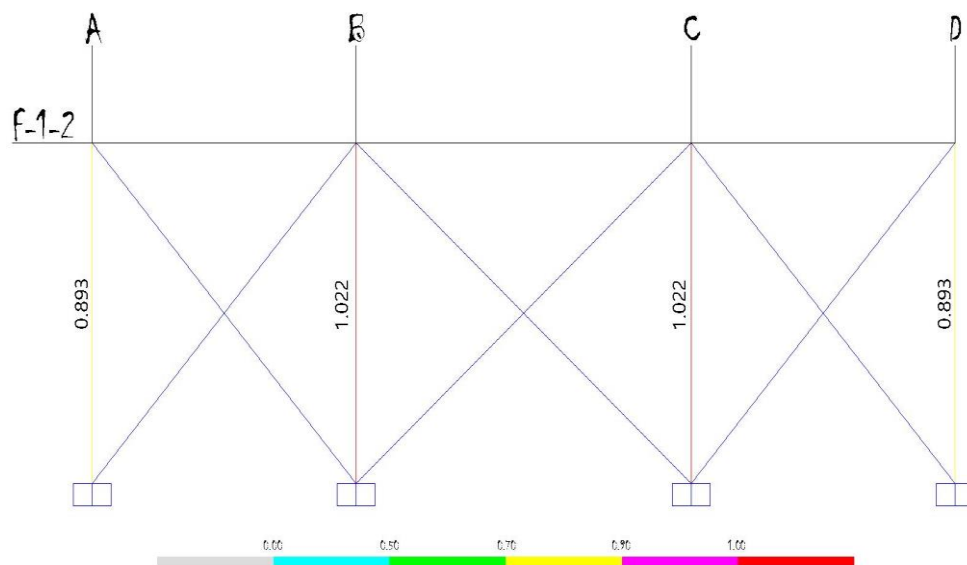
Figure 8. Shows the result of analysis for 10-percent probability of exceedance.

The findings for the 10 percent probability of exceedance reveal a different scenario. Due to the reduced severity of the earthquake, none of the columns fail under the lateral load combination. However, under the gravity load combination, depicted in Figure 8, the columns become overloaded with a capacity ratio of 1.022. This suggests that the columns possess sufficient strength to withstand a 10 percent earthquake. Nonetheless, the failure under the gravity load combination signals the need for further reinforcement by increasing their dimensions to enhance their strength.

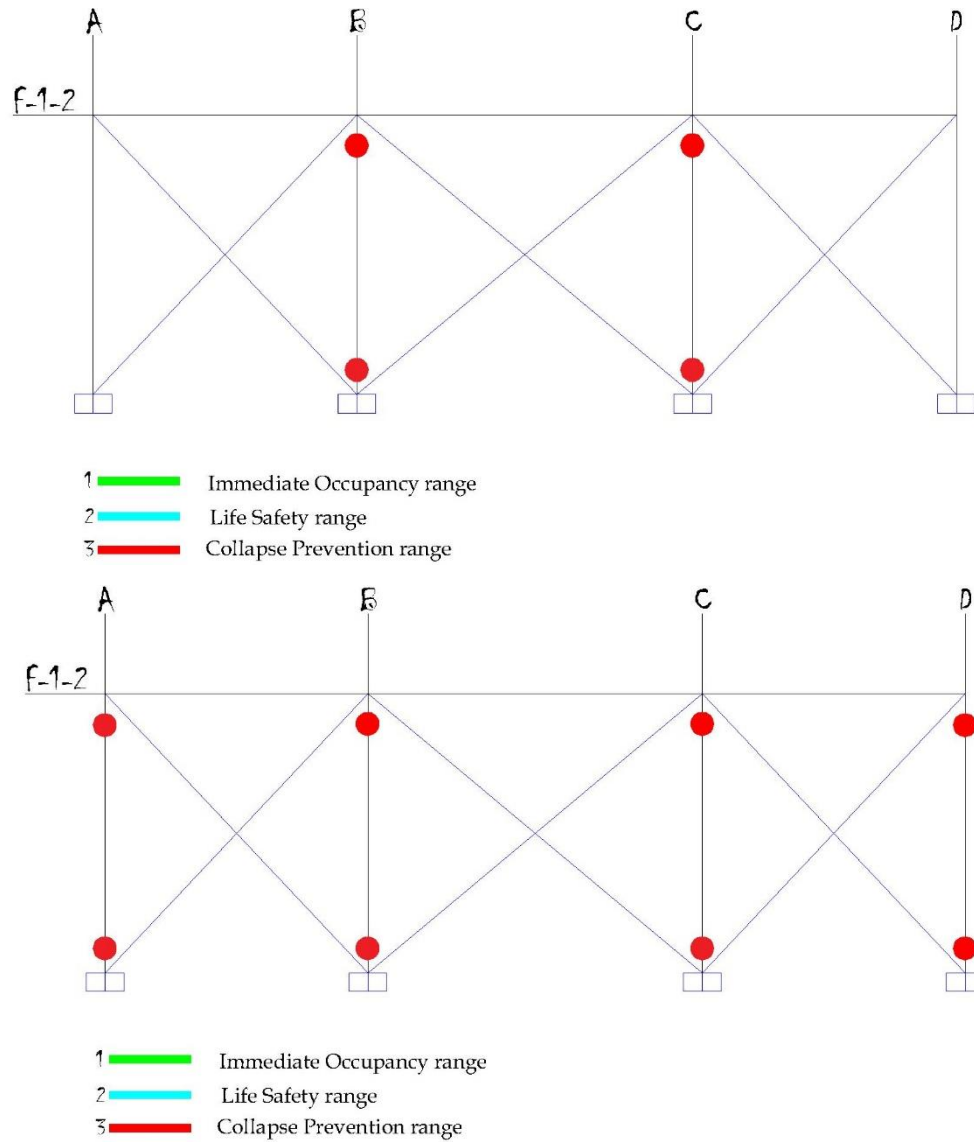
Figure 11. Plastic hinges creation as the result of pushover in X direction (Step-16, 13mm of displacement)

The push-over analysis conducted in the X direction, with a target displacement of 25mm, reveals significant findings. Initially, plastic hinges form at the tops of the four central columns, as depicted in Figure 9. As the load intensifies, these plastic hinges extend towards the base of the columns, as illustrated in Figure 10. Subsequently, as the force continues to increase, stress accumulates at the edge columns, leading to the initiation of plastic hinges there, as shown in Figure 11. Interestingly, none of the beams develop plastic hinges

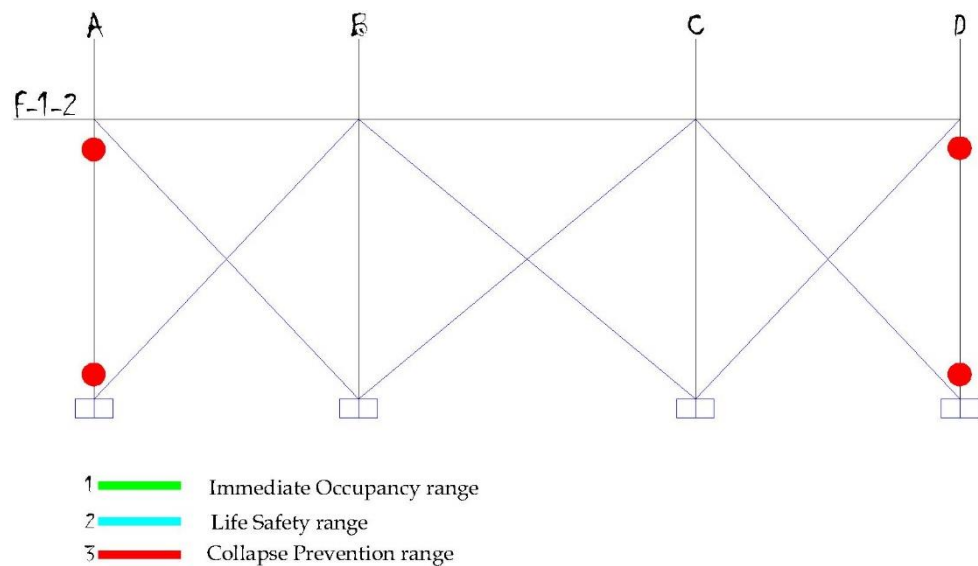
Figure 13. Plastic hinges creation as the result of pushover in Y direction (Step-9, 19mm of displacement)

The outcomes of the push-over analysis in the Y direction mirror those observed in the X direction, as depicted in Figures 12, 13, and 14. However, a notable distinction is the greater flexibility of the structure in this orientation. Consequently, the failure mode in the Y direction is less abrupt compared to the X direction. This distinction becomes apparent when comparing the push-over curves for both directions, as illustrated in Figure 15. The graph interpretation reveals that the structure exhibits greater stiffness in the X direction, allowing it to withstand significant base shear forces with minimal displacement.

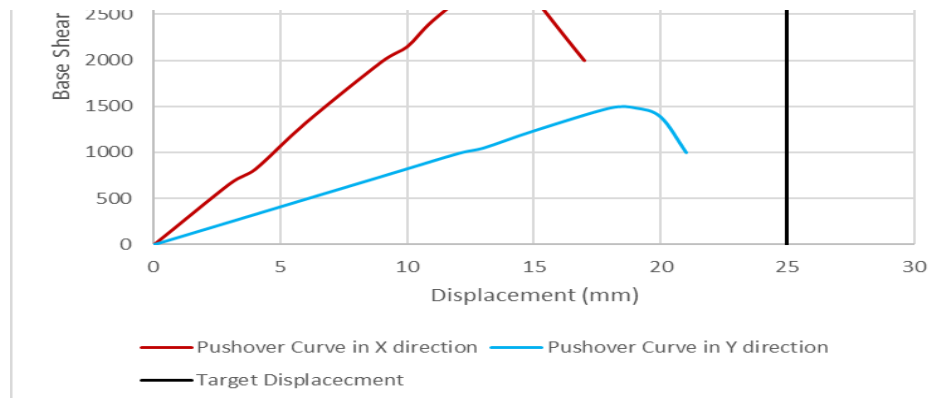
Figure 15. Push-over curve in X and Y direction with 25mm of target displacement.

3. A detailed examination of the push-over curve suggests that opting for 40*40cm columns instead of 30*30cm columns, coupled with the omission of ground beams, would substantially enhance the structure's performance and resilience to stronger ground shaking. This optimization strategy, based on the analysis of both 2-percent and 10-percent probability scenarios as well as push-over analysis, offers potential for significant cost savings and a more robust structural design.
